## ILA-USMX JOINT SAFETY COMMITTEE

# OSH ALERT 2019-08 [20 May 2019]

## Inspection & Servicing of Industrial Truck Wheel Rims

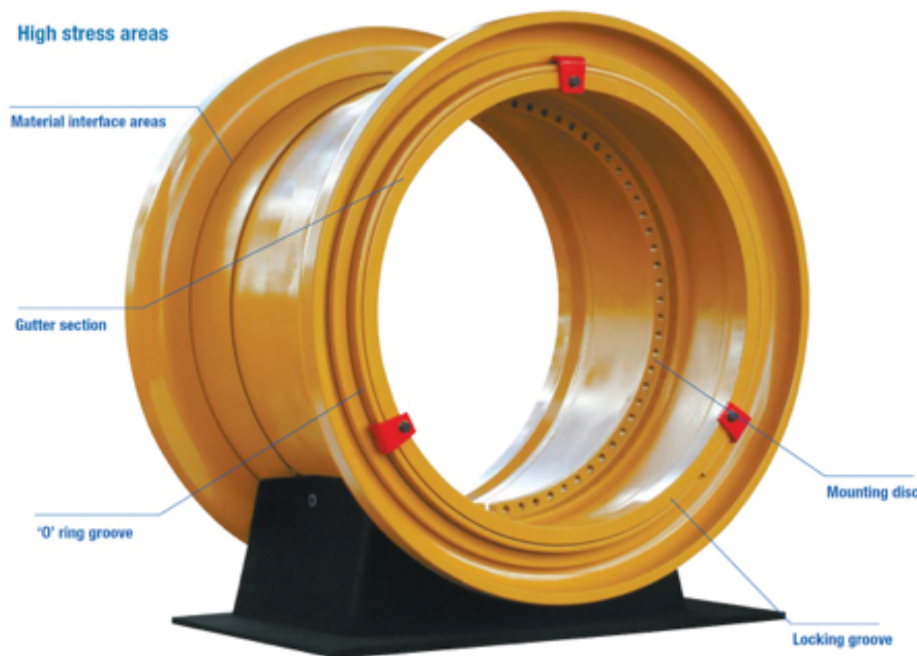
In both cases, it appears somewhat likely that the underlying causes included cracks that had developed within the structure of the wheel rims, themselves.

**Above: Typical Areas of Wheel Rim High Stress**

Following the relevant rim wheel manufacturer's service manual and adhering to the stipulated inspection/service intervals and protocols would likely go a long way in saving the lives of a few waterfront mechanics going forward. In that light, we provide a link to an example of one such model service manual: [https://www.accuridecorp.com/files/2012/10/Accuride-Wheels-Rim\\_Wheel-Safety-and-Service-Manual-ACC7-0002-Rev-4-06-22-12.pdf](https://www.accuridecorp.com/files/2012/10/Accuride-Wheels-Rim_Wheel-Safety-and-Service-Manual-ACC7-0002-Rev-4-06-22-12.pdf)
