ILA-USMX JOINT SAFETY COMMITTEE

OSH Circular 2015-04 (31 March 2015)

COMPLACENCY CAN KILL!

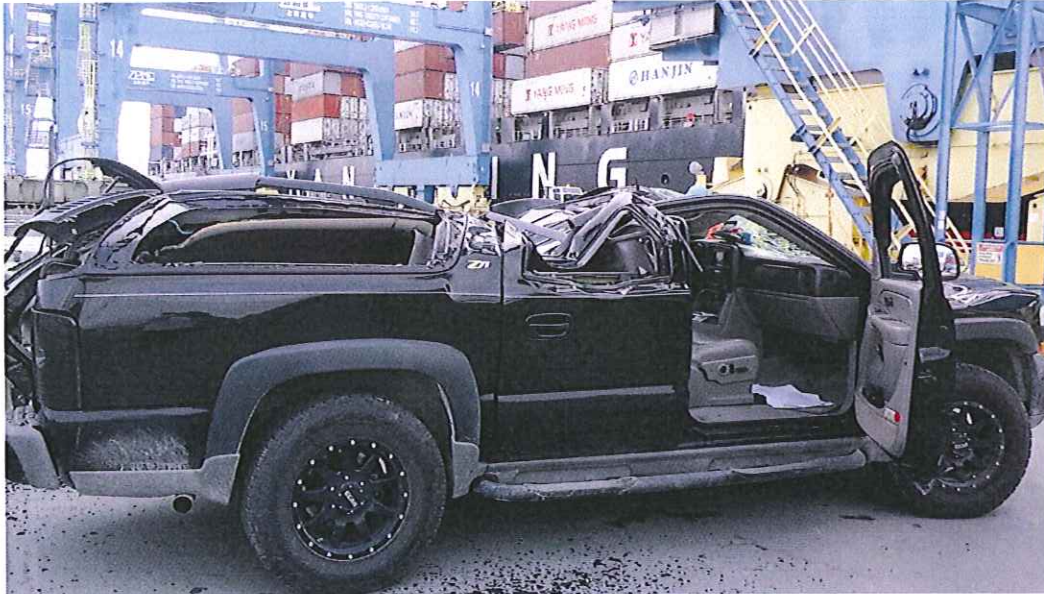
The photo above is of a marine terminal operator's company car that, on 26 March at a South Atlantic port, had a 40 ton hatchcover landed on it while temporarily parked in the backreach of a container crane. Two management representatives were occupying the front seat at the time. Incredibly, they escaped with only minor injuries. Obviously, this incident could have had a much more severe outcome.

After some inquiry, the JSC is made to understand that staff on the ground had been assigned to assist the crane operator in landing the cover in the crane's backreach. Before it was landed, however, that staff decided that the work was essentially done and that they could move on to their next activity.

In the period of time between their walking away and the final lowering of the cover onto the backreach's surface, the car shown above moved into what was ultimately a very dangerous position. The size of the cover, itself, blocked the port authority crane operator's view below.

- 1). Signalers/landers (limited to only one per crane) should see the load they are guiding come to completion before doing anything else.**
- 2). Crane operators should not continue to hoist or lower loads in the absence of a required signalperson.**
- 3). All employees, whether on foot or in vehicles, should be aware of and avoid caught-in-the-bight dangers at all times while at work.**
